Manhole Inspection Summary

Manhole # S07KK1023MH

Insp Date: **5/18/07 1:32 PM**

Location Address: **REISTERSTOWN RD**

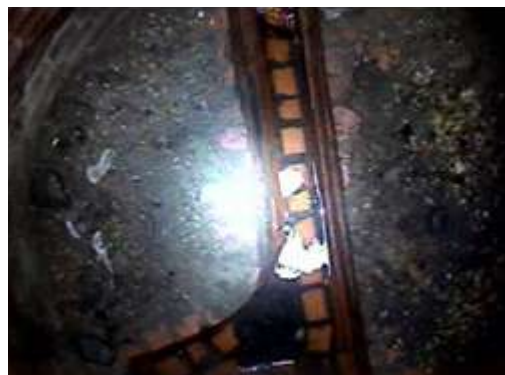
Top View

DEBRIS ON BENCH

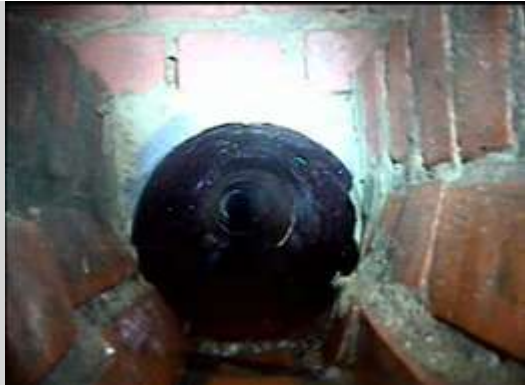
12 O'Clock Outflow

8 in. Circular Gravity Sewer
Pipe Out @ 12 O'Clock

Pipe Height: (in.) Direct
Pipe Material: **Clay** ☐ Pipe Lined
Invert Depth: **6.80** (ft.) Flow Characteristics: **Slow**
Deposits: ☒ None ☐ Mud ☐ Sludge ☐ Debris ☐ Grease
Silt Depth: (in.) Deposits Extent:
Infiltration: **None** Pipe Seal Cond: **Sound**

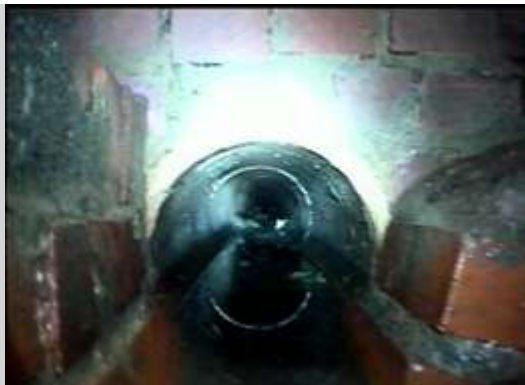
6 O'Clock Inflow

8 in. Circular Gravity Sewer
Pipe In @ 6 O'Clock

Pipe Height: (in.) Direct
Pipe Material: **Clay** ☐ Pipe Lined
Invert Depth: **6.79** (ft.) Flow Characteristics: **Slow**
Deposits: ☒ None ☐ Mud ☐ Sludge ☐ Debris ☐ Grease
Silt Depth: (in.) Deposits Extent:
Infiltration: **None** Pipe Seal Cond: **Sound**

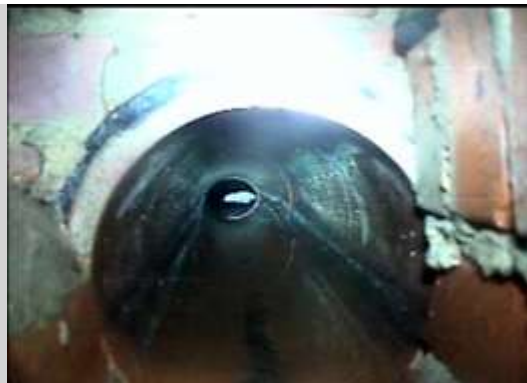
8 O'Clock Inflow

8 in. Circular Gravity Sewer
Pipe In @ 8 O'Clock

Pipe Seal Cond: **Cracked**

Connects To: **House connection / Service line**
